# EARTHQUAKE EXPOSES CORRUPTION

Transparency Challenges for Turkey

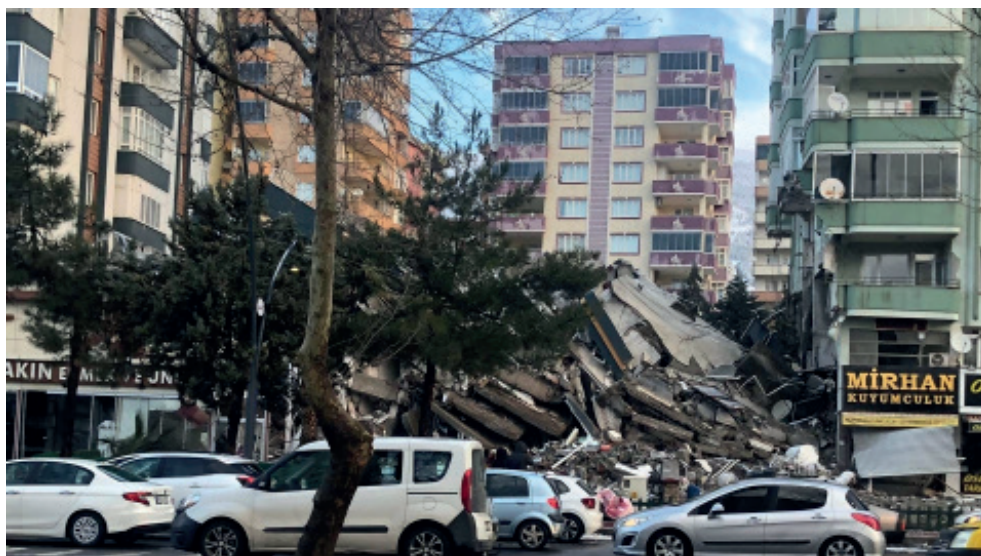
*Fazilet Block A,  
after the earthquake*

The list of violations discovered encompassed several critical breaches, notably the absence of permits for the bakery's chimney, modifications to structural integrity beneath supporting beams, attachment of the chimney to a supporting column, unauthorized alterations to building facades, inadequate insulation, and excessive load within the bakery premises.<sup>2</sup> Following the earthquake, evidence presented by victims revealed the bakery's contribution to the collapse, including excessive loads and structural alterations. However, despite the diligent efforts spanning a 13-year legal pursuit, intervention from state institutions remained elusive. Moreover, subsequent court rulings, including a post-earthquake expert report, failed to acknowledge the bakery's association with Block A, further exacerbating the plight of the affected parties.

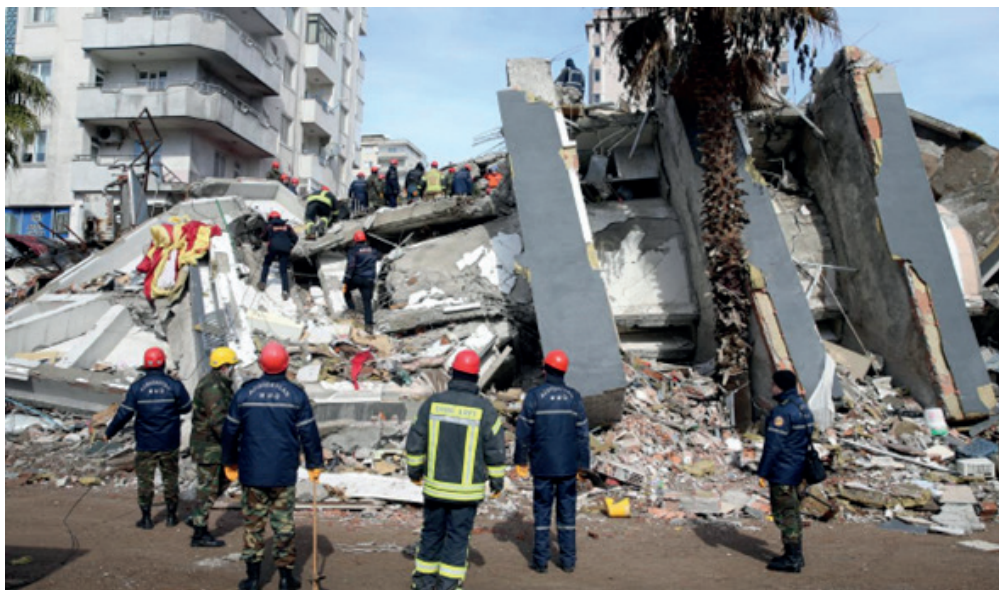
*Ezgi Apartment, after the earthquake (TRT HABER)*

During the February 6, 2023, earthquake at 04:17, the building collapsed towards the bakery within 15 seconds, claiming the lives of 36 individuals. Despite the building's robust foundation and relatively new construction, suspicions regarding extensive damage attributable to the business below emerged. The contractor's liability is considered diminished due to architectural discrepancies during construction.

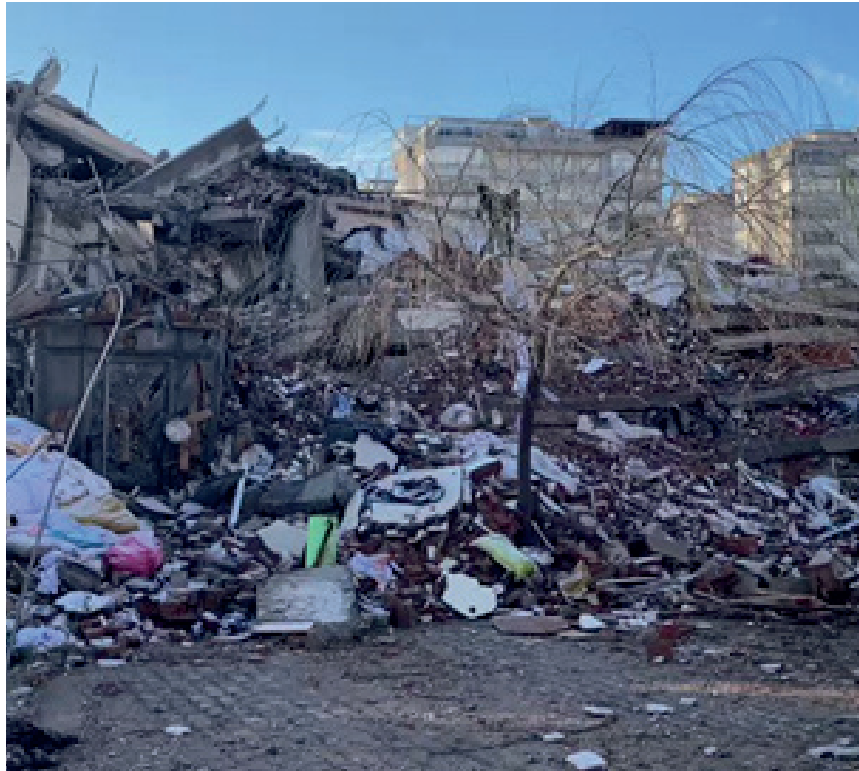
Lawyer Ömer Faruk Tütüncüoğlu, representing victims of the Palmiye site, emphasized issues such as poor-quality materials and inadequate reinforcement, attributing negligence bordering on intent to public officials. He noted a shift in expert assessments, indicating a departure from shielding officials based on political affiliations and vested interests.<sup>4</sup>

*Palmiye, after  
the earthquake (X)*

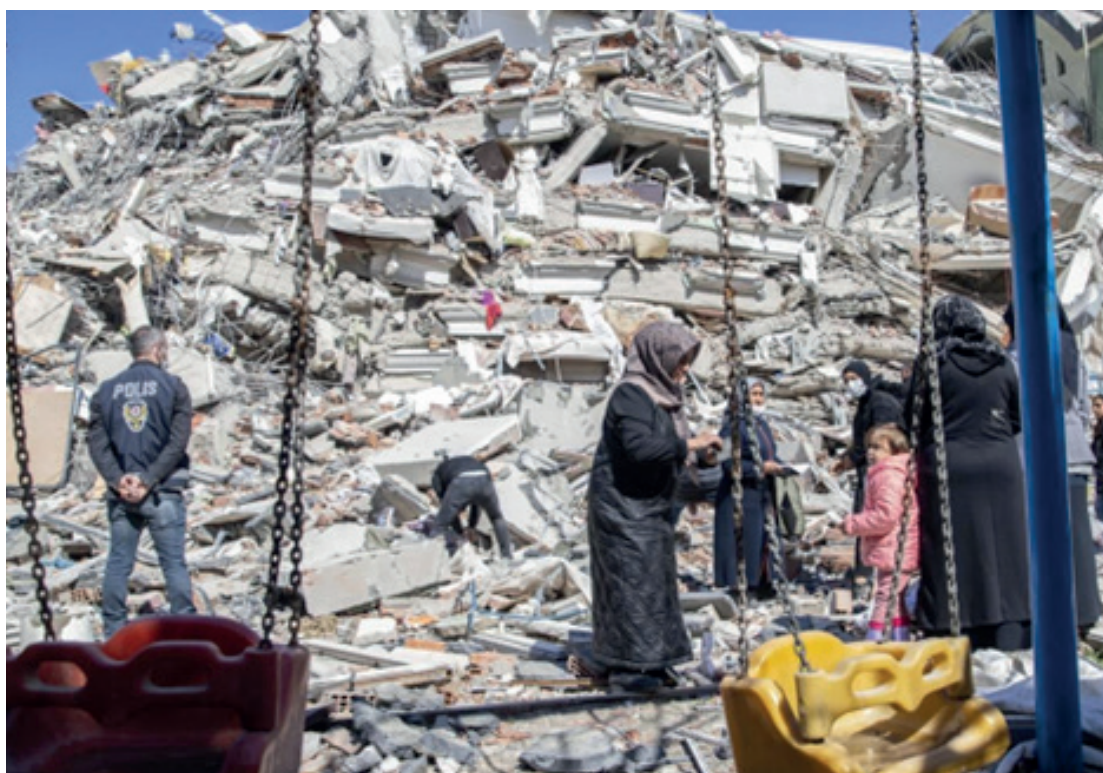
*Hamidiye, after the earthquake (TRT HABER)*

In the case of the Hamidiye site, the expert report prepared by Konya Technical University identified the Municipal Building Control Unit, along with the contractor and project author, as primarily responsible. The report highlighted numerous areas for improvement in the project, including a lack of ground studies, inadequate structural elements, and non-compliance with seismic regulations. Municipal officials were faulted for approving a project with errors without demanding revisions.

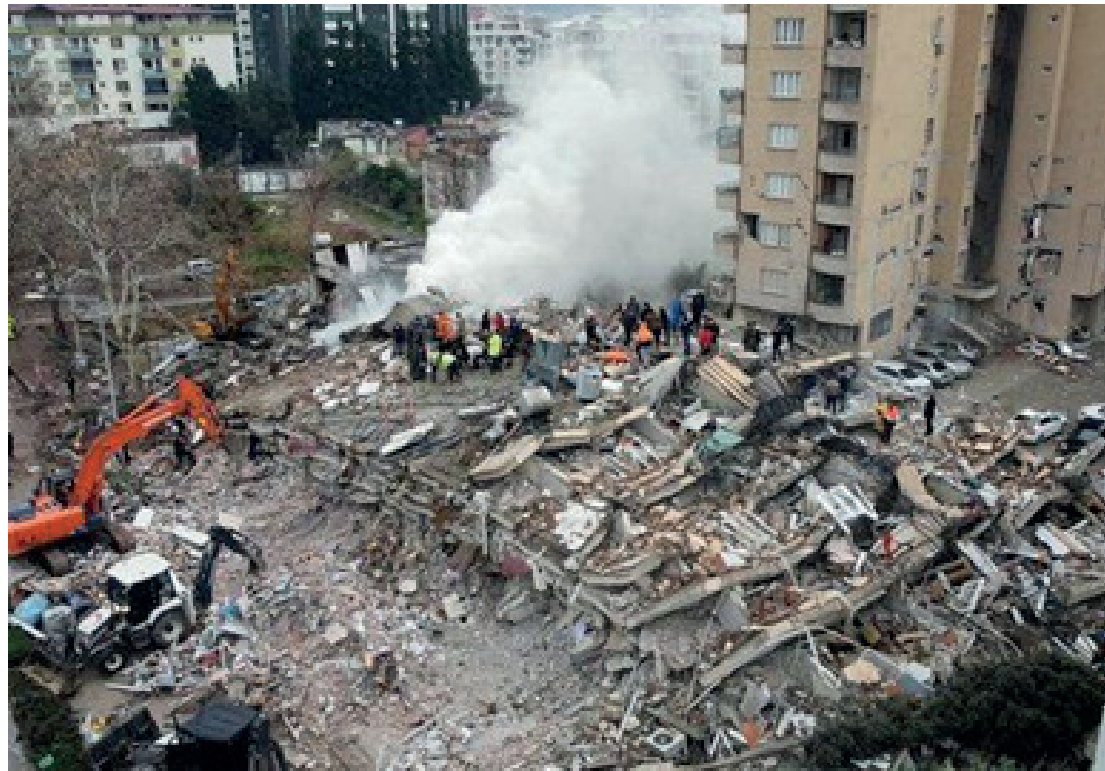
The expert analyses conducted by Karadeniz Technical University meticulously detailed the violations present in these structures, ranging from unauthorized structural modifications to inadequate reinforcement measures. Notably, the Selam Apartment, consisting of 44 units, crumbled under seismic activity, claiming the lives of 83 individuals, including Zahide Şeker's husband and daughters. Similarly, the Reyyan Apartment, initially comprising nine floors, collapsed due to unauthorized additions, leading to the tragic demise of 52 occupants. L Block, where 57 people perished, faced legal action against Tefvik T. and others for negligence in overseeing the building's modifications.<sup>6</sup>

*Ebrar, after the earthquake (ABC)*

However, amid the legal maneuvering, it is evident that the loss of lives at the Ebrar Site was entirely preventable. Expert reports highlighted significant deficiencies in construction materials and adherence to safety regulations, with substandard concrete quality and insufficient structural design emerging as primary contributors to the collapses. Moreover, the absence of proper enforcement mechanisms and regulatory oversight allowed these violations to persist, ultimately resulting in the catastrophic loss of lives.

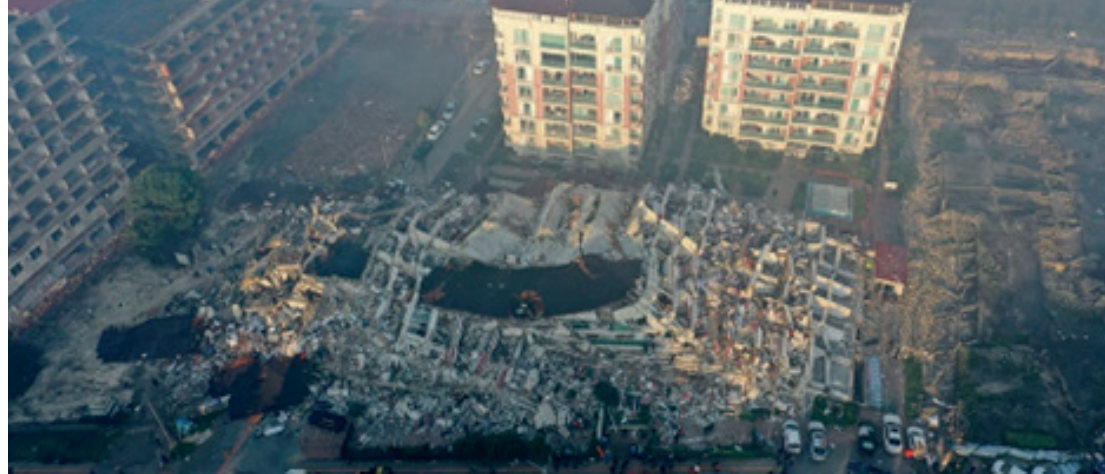
Amidst this calamity, concerns arose regarding the structural integrity of the collapsed blocks, particularly regarding suspicions of column tampering. Residents of the site, deeply affected by the loss and destruction, pursued legal recourse by filing a complaint with the prosecutor's office. However, their efforts were met with disappointment as the prosecutor's office rendered a decision of non-prosecution, effectively halting any further legal actions in the matter.

The unfortunate collapse of blocks A and B, juxtaposed against the survival of blocks C and D, underscored the complexities and implications of the disputes between the parties involved.

*Rende Block A and Block B  
after the earthquake (Sözcü)*

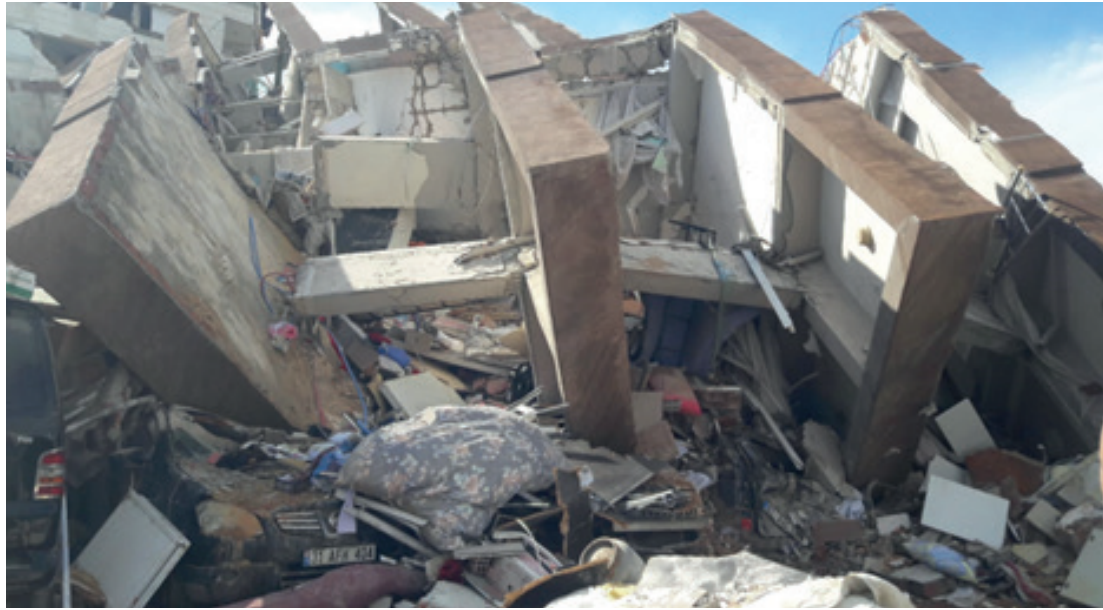
collapse of the building where her family resided, underscoring the dire consequences of the regulatory failures in construction oversight. The collapse of the Fuat Koku Site sheds light on systemic issues within the building regulation framework, with reports indicating the absence of proper oversight and documentation. The collapse of the building has revealed a concerning lack of building permits and documentation, a problem prevalent among many older structures in Hatay.

*Fuat Koku,  
after the earthquake*

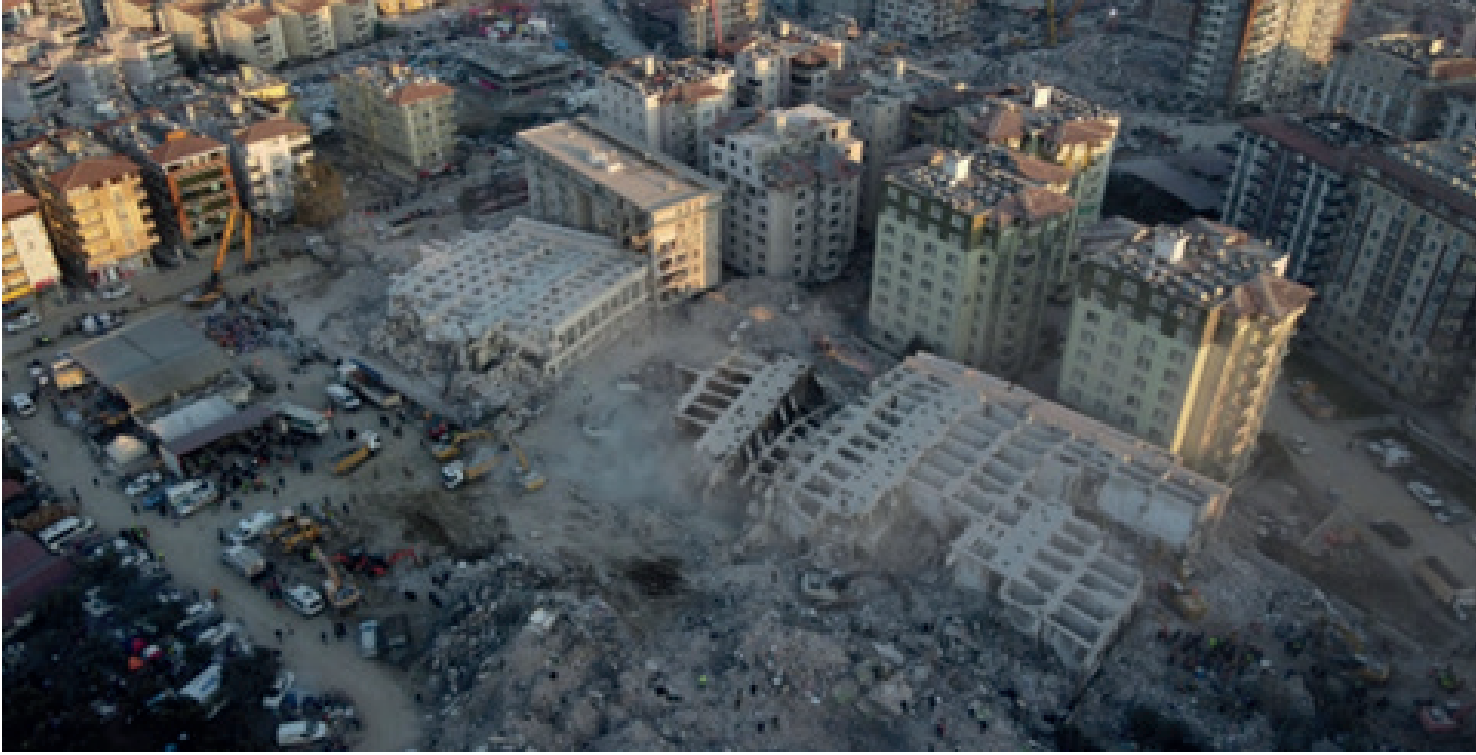
In the aftermath of the devastating earthquakes that shook Kahramanmaraş, a critical investigation unfolded regarding the collapse of the Rönesans Residences in Hatay with almost 1000 losses. A second expert report highlighted the structural flaws that led to the tragic incident. It revealed that the creation of window-like voids above the basement floor resulted in the formation of short columns, ultimately leading to the building's collapse. Furthermore, deviations from proper construction practices, such as improperly bent column reinforcements, were identified as contributing factors.

underground water leakage and indicating a saturation of the ground with water. These findings underscored the significance of comprehensive investigations into building practices and ground conditions. Recommendations for further soil analysis and comparison with pre-construction assessments were made to ensure structural integrity and safety in future construction projects.

*Rönesans, after the earthquake (Gazete Oksijen)*

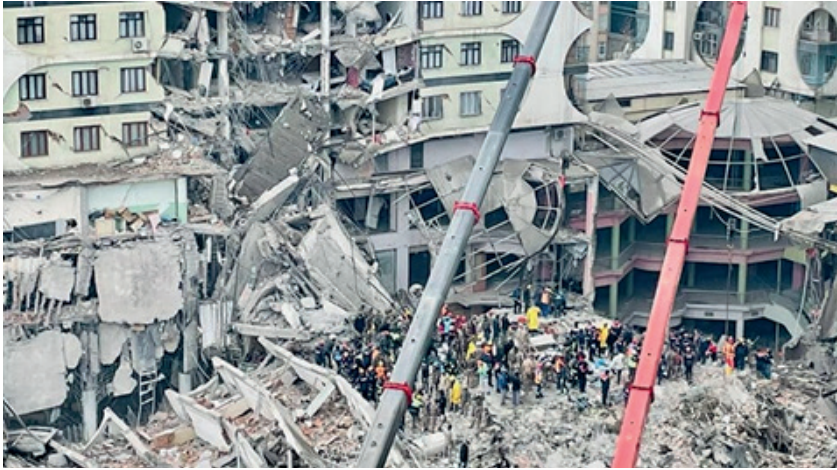
Concerns regarding the hotel's structural integrity surfaced as early as 2020 following damage incurred during the Sivrice earthquake. Discussions regarding its demolition ensued, yet tragic events unfolded due to significant negligence. Subsequently, following the Elazığ earthquake, the building underwent inspection and received a structural integrity report, although claims suggest prior utilization of the hotel as a business center. These circumstances led to the arrest of the hotel owner, Zafer Kırçuval, who also serves as the deputy mayor of the Metropolitan Municipality. Despite expert reports, legal proceedings have stagnated over the past ten months.

*Kırçuval Hotel,  
after the earthquake (AA)*

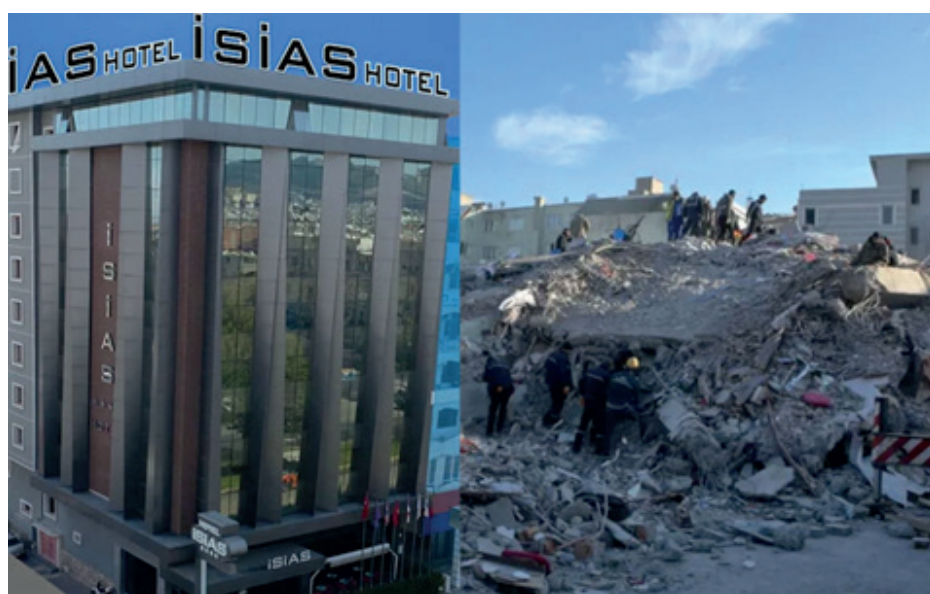
Despite having a permit for up to 5 floors, the collapsed hotel had seven floors, indicating a clear violation of building regulations. Core samples from the building revealed flaws, leading to laboratory studies concluding that a compliance license should not have been granted. Furthermore, the concrete quality could have been more suitable for a multi-story structure, and the connection points of columns and beams were faulty. The iron used in construction did not meet standards, either lacking ribs or being incompatible with cement, prohibited in multi-story buildings. Samples also indicated using inferior construction materials such as creek gravel and sand.

Additionally, the building remained idle for approximately ten years after a workplace accident in 1991, during which time the structure deteriorated. Originally designed as a family apartment, hotel owners' intervention resulted in alterations outside the building's intended use.

*Isias Hotel, before and after the earthquake (Rudaw)*
